CASE STUDY

Union Electric Steel

Pump Overhaul and
Repair

Gas Pump

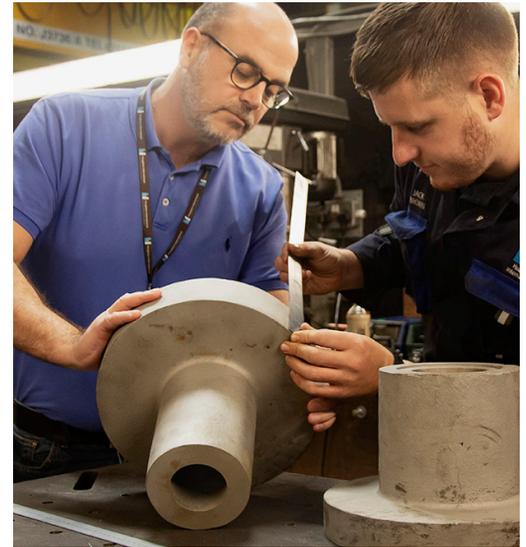
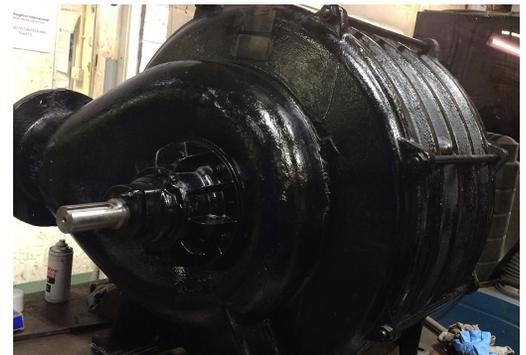
A Lamson Corp gas pump had come in for repair with severe wear and issues including damaged impellers and bearings and a bent shaft. The customer required the pump to be returned in as short a timescale as possible due to its importance to their operations.

Houghton International successfully completed repair work on a gas pump for Union Electric Steel.

One impeller was beyond repair so this was removed and one stage of the pump was taken out. This meant the pump could still be used by the customer for lighter duties whilst a number of new spare parts were manufactured.

A new set of impellers and a new shaft were manufactured, with the Houghton International team making modifications to improve the design and reverse engineering components where necessary. To ensure that a second set of replacement parts would be available for future repair work, an additional set of spares comprising of the impellers and shaft were also produced.
